Oswego Ridge Condominiums

ONE YEAR WARRANTY WALK

**Oswego Ridge Condo
Condominium Owners
Association
86 Kingsgate Road
Lake Oswego, OR 97035**

May 13, 2019

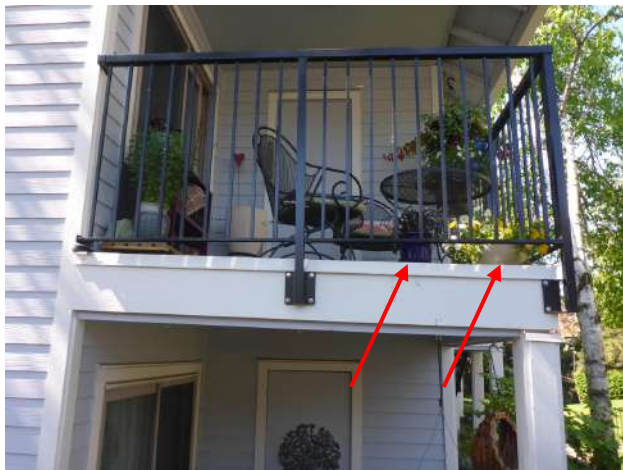
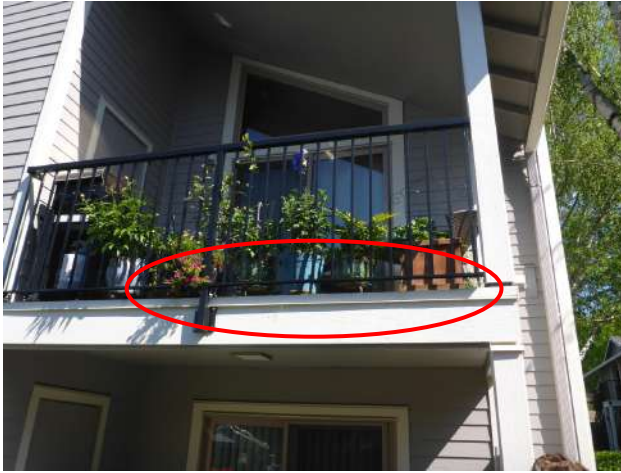
All buildings

Maintenance note for ORC HOA: Pots are required by the manufacturer to be on pedestals which allow adequate drainage and prevent water ponding underneath and on deck surface coating.

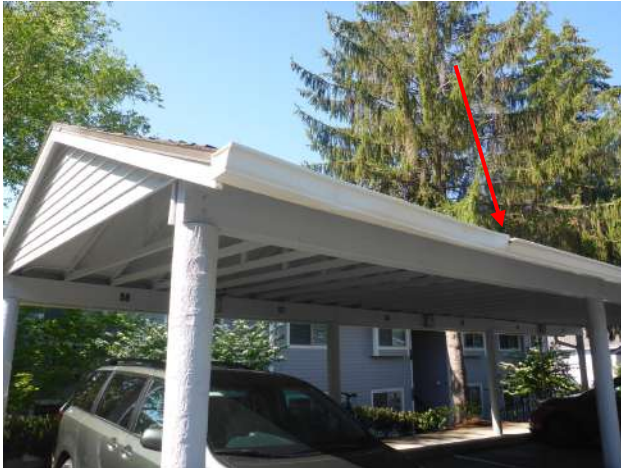
Carport in front of Building F

Maintenance note for ORC HOA: Carport gutter damaged. Noted on site as an item damaged after construction, and outside warranty-covered work.

Forensic recommends HOA have I&E make repairs to maintain warranty of associated building components.

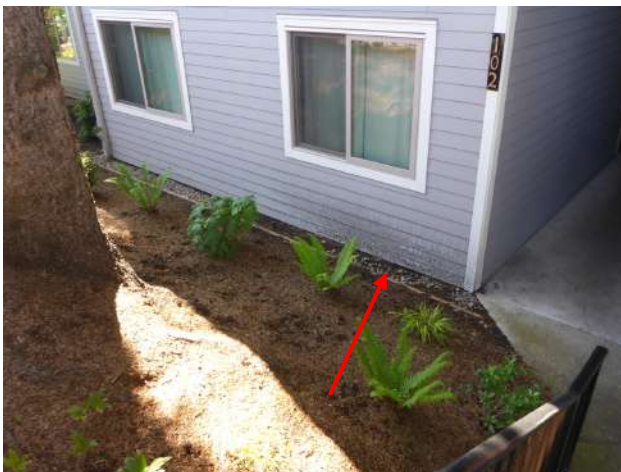
Bldg. E

Unit 102, front elevation – splashing of dirt and bark dust onto cladding from plugged gutters and/or downspouts.

Maintenance note for ORC HOA: Biannual cleaning of gutters and downspouts recommended. More frequent cleanings may be needed as needed on areas that receive higher volumes of natural debris.

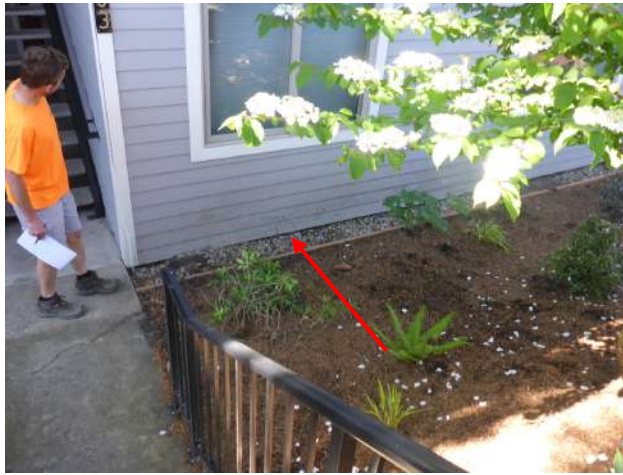
Bldg. E

Unit 103, front elevation – splashing of dirt and bark dust onto cladding from plugged gutters and/or downspouts.

Maintenance note for ORC HOA: Biannual cleaning of gutters and downspouts recommended. More frequent cleanings may be needed as needed on areas that receive higher volumes of natural debris.

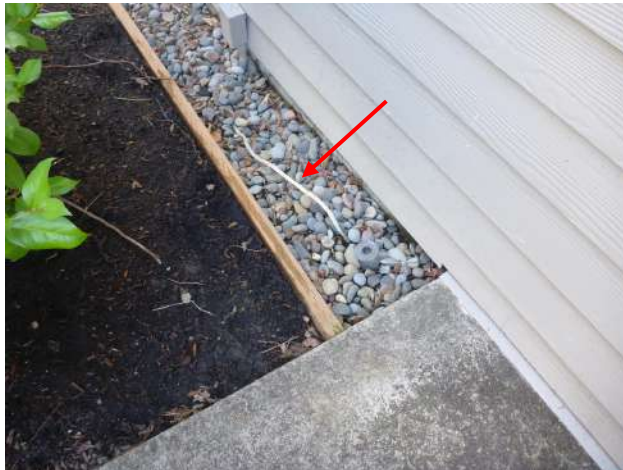
Bldg. I

Unit 101, side elevation – Exposed wire in French drain system.

Maintenance note for ORC HOA: Refer to professional electrician for recommendations.

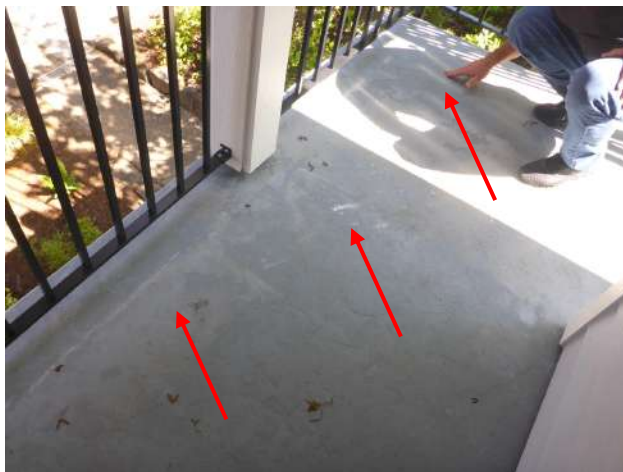
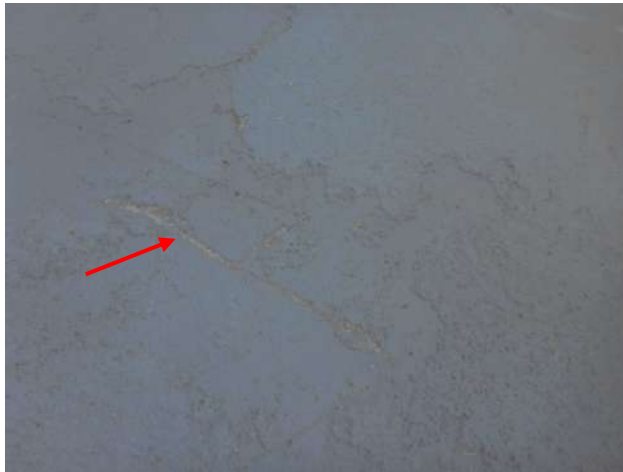
Bldg. G

Unit 201, front elevation, – deck surface coating discolored and damaged. Noted on site as an item damaged after construction, and outside warranty-covered work.

Additional photo of condition shown previously illustrating damage to deck coating.

Forensic recommends HOA verify damage has not caused water to penetrate through deck coating system. Then have I&E make appropriate repairs, cleaning and resurfacing per manufacturer requirements, to maintain warranty of associated building components.

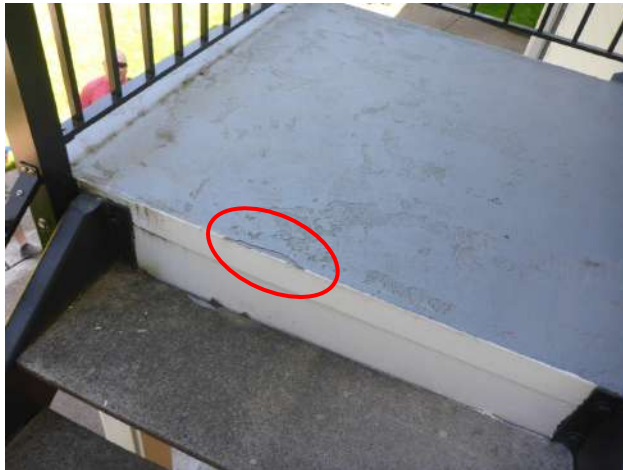
Bldg. A

Unit 203, front elevation – Deck coating chipped and damaged. Noted on site as an item damaged after construction, and outside warranty-covered work.

Forensic recommends HOA verify damage has not caused water to penetrate through deck coating system. Then have I&E make repairs, cleaning and repairing per manufacturer requirements, to maintain warranty of associated building components.

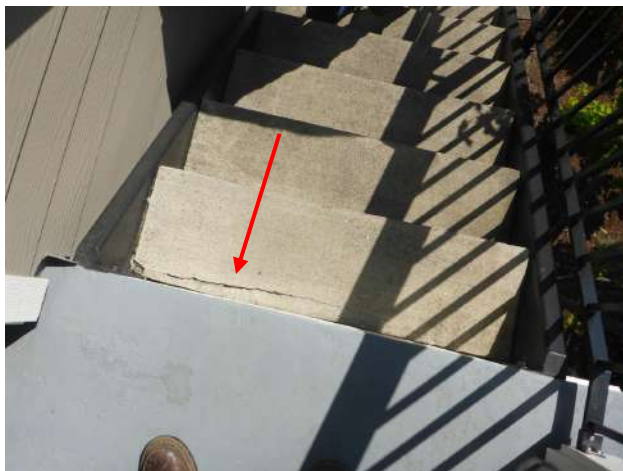
Bldg. C

Maintenance note for ORC HOA: Newly observed cracked top concrete stair step found at unit 201 entry.

Forensic recommends damaged steps be replaced immediately. HOA discussed on site this is included in upcoming repairs needed to similar conditions on property.

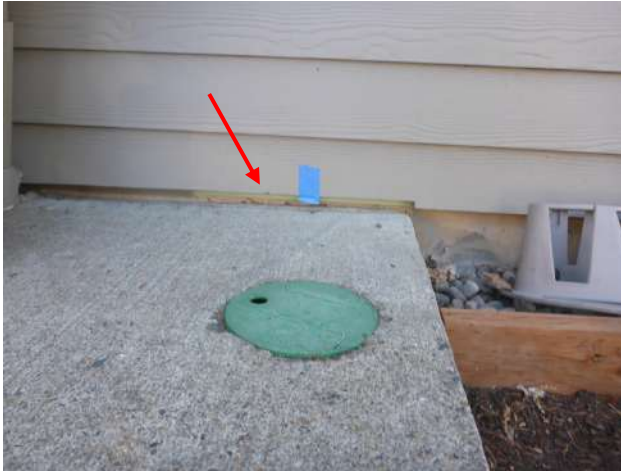
Bldg. F

Unit 103, front elevation – Contractor to apply paint at omitted areas on base of wall flashing.

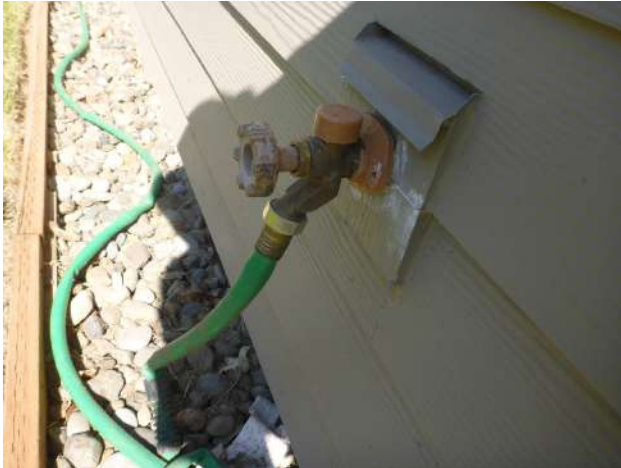
Bldg. F

Unit 106, side elevation – Contractor to touch up paint at hose bib mounting block.

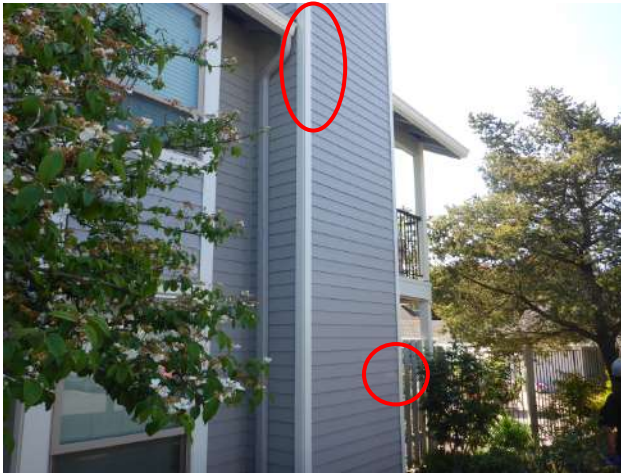
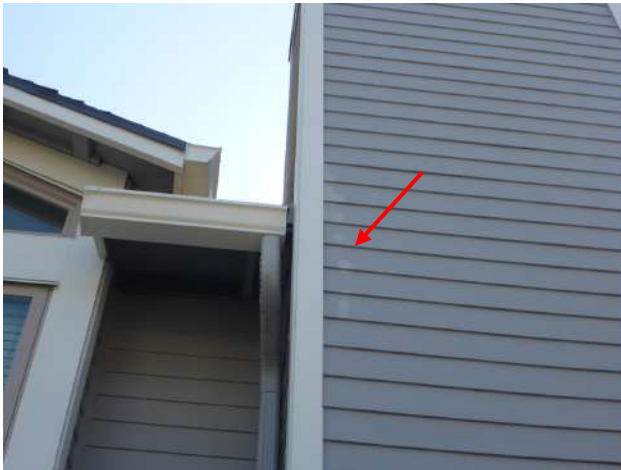
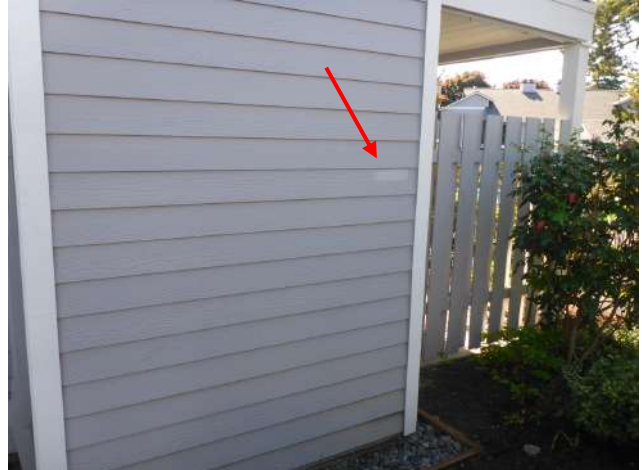
Bldg. E

Unit 104, side elevation – Contractor to touch up paint to match building color. Reference photos to left and close up photos below.

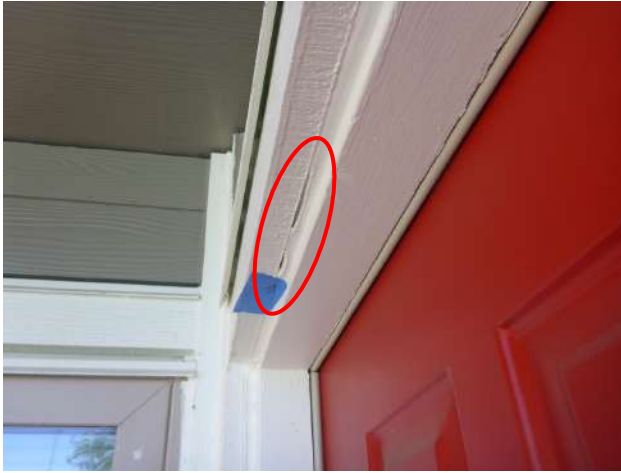
Bldg. I

Unit 201, front elevation – Sealant void at front door head. Contractor to repair sealant per manufacturer recommendations.

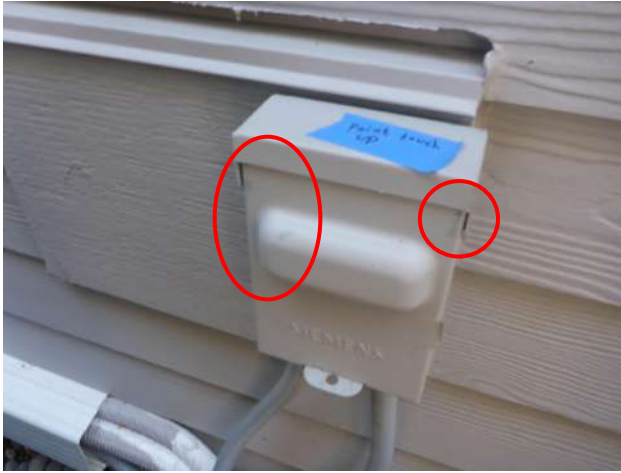
Bldg. H

Unit 104, front elevation – Contractor to touch up paint on utility box near entry.

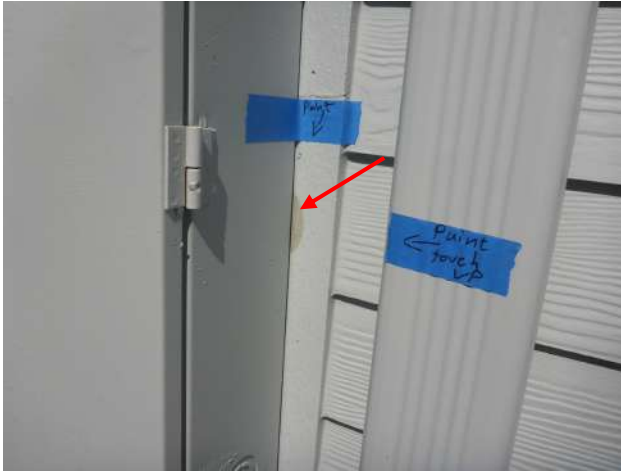
Bldg. G

Unit 102, rear elevation – Contractor to touch up paint at utility box mounting block.

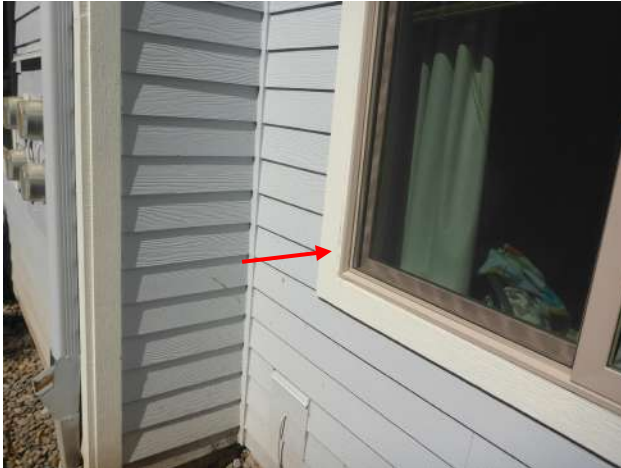
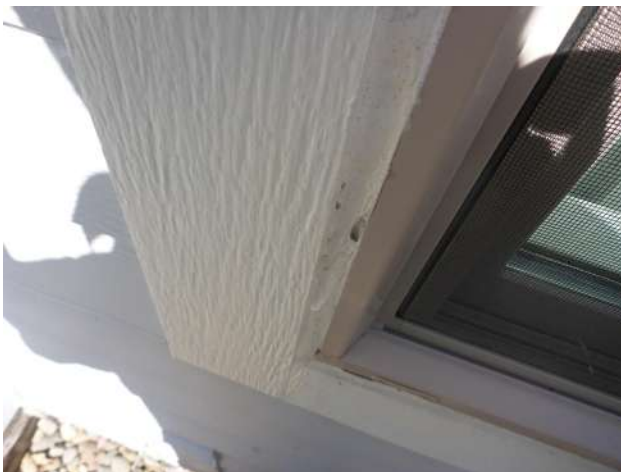
Bldg. G

Unit 103, rear elevation – Contractor to repair sealant joint void at window corner dynamic joint.

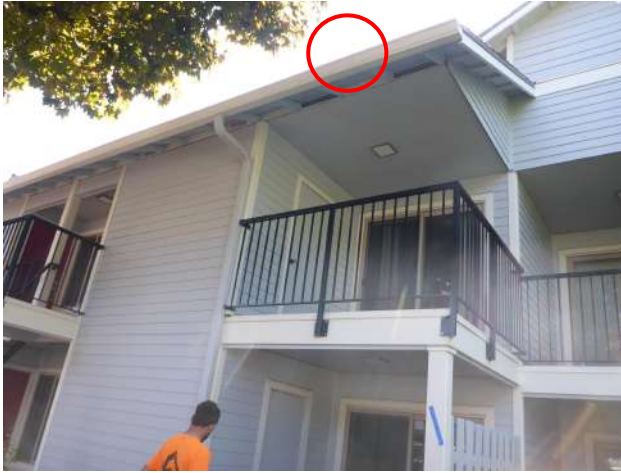
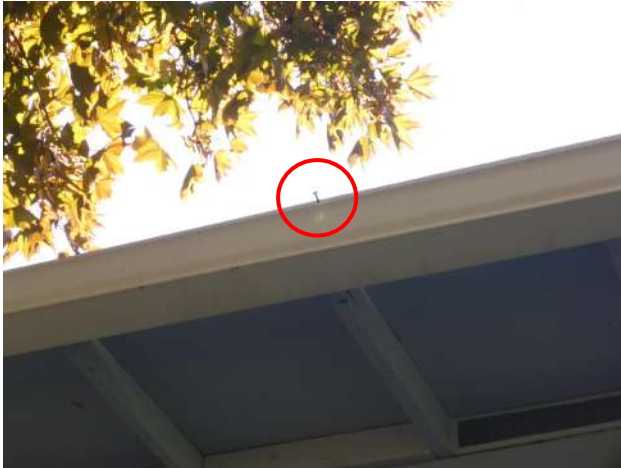
Bldg. G

Unit 203, front elevation – Contractor to ensure gutter fasteners are fully and securely seated.

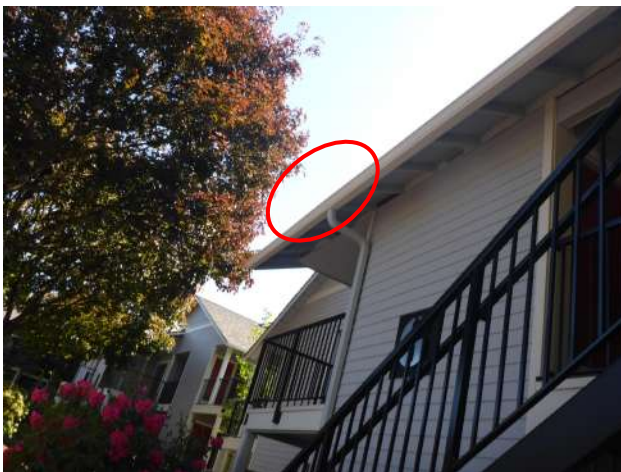
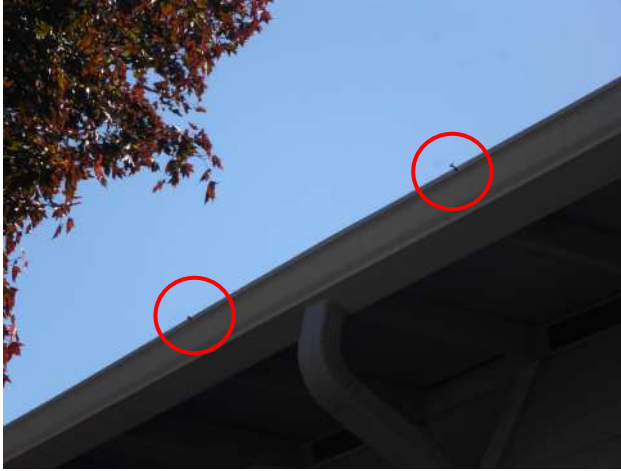
Bldg. G

Unit 202, front elevation – Contractor to ensure gutter fasteners are fully and securely seated.

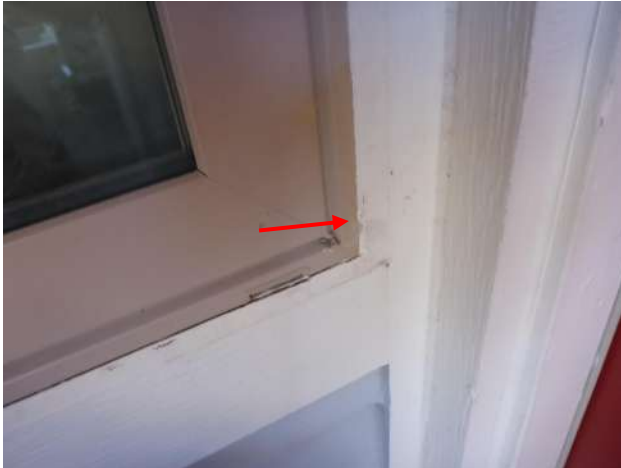
Bldg. G

Unit 103, front elevation – Contractor to repair sealant joint void at window corner dynamic joint.

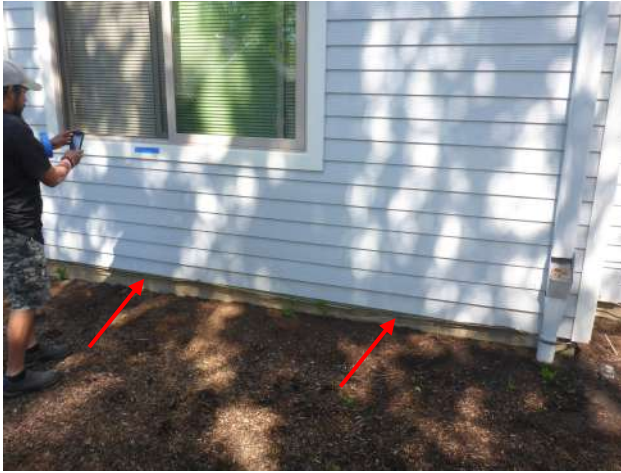
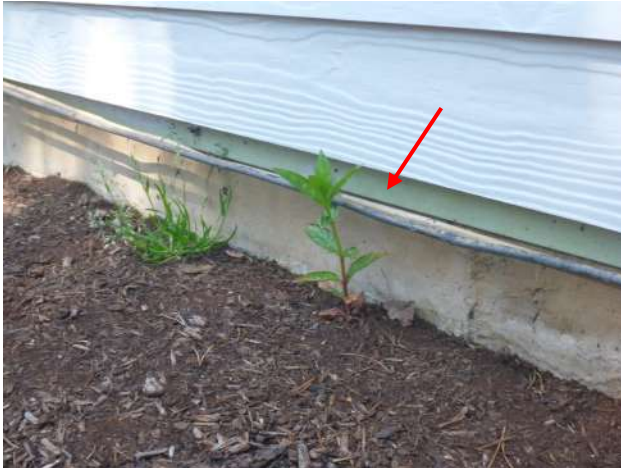
Bldg. A

Unit 102/103, rear elevation – Contractor to apply paint at omitted areas on base of wall flashing.

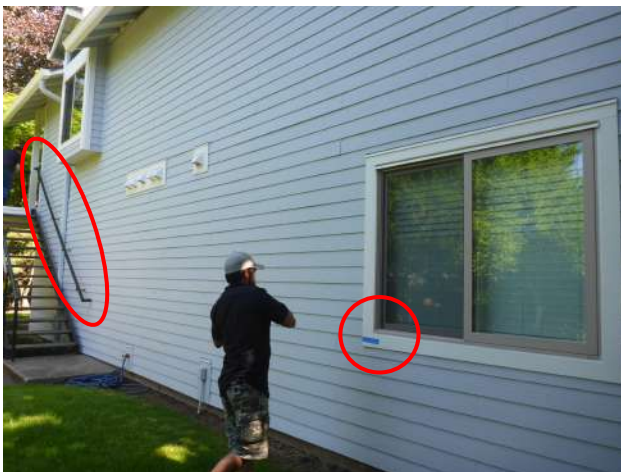
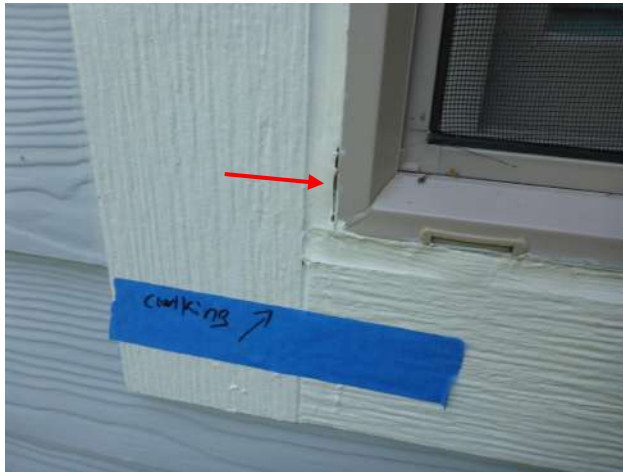
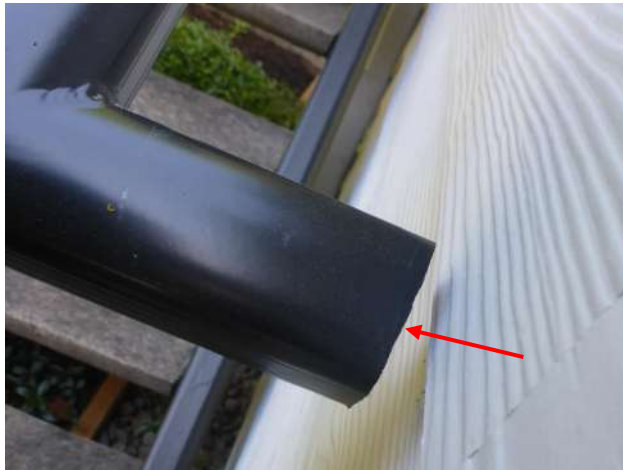
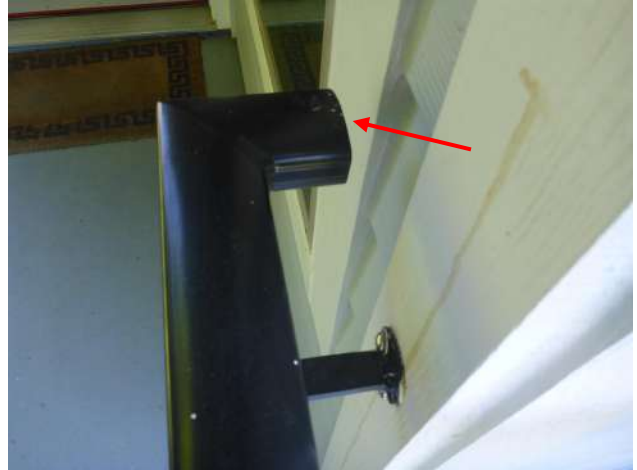
Bldg. A

Unit 105, side elevation – Contractor to repair sealant joint void at window corner dynamic joint, and missing railing end caps at exterior stairs.

Close-up photo of condition shown previously illustrating sealant void (left), and missing railing end caps (below).

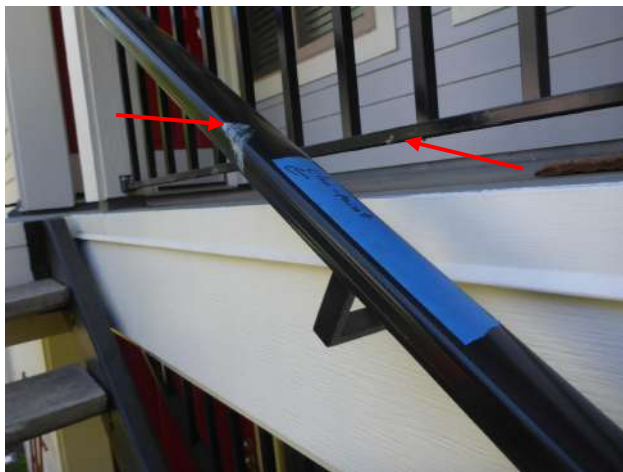
Bldg. A

Unit 104/204, front elevation – Contractor to clean paint on railings.

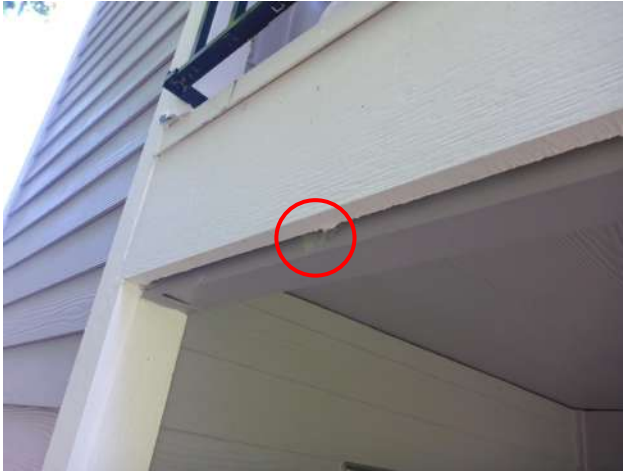
Bldg. B

Unit 101, rear elevation – Contractor to apply paint at omitted areas on deck flashing.

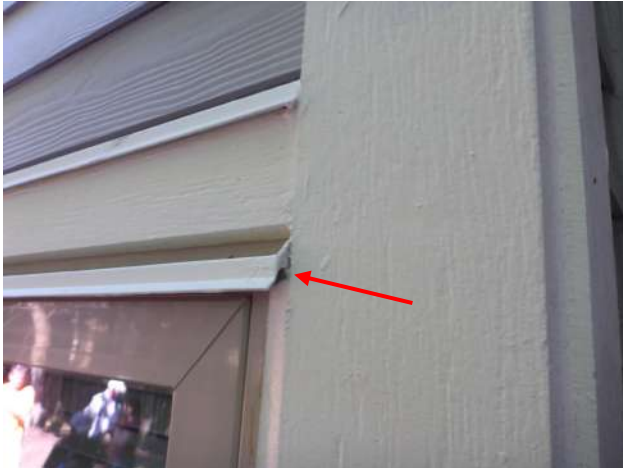
Bldg. B

Unit 101, rear elevation – Contractor to repair sealant joint void at window head corner dynamic joint.

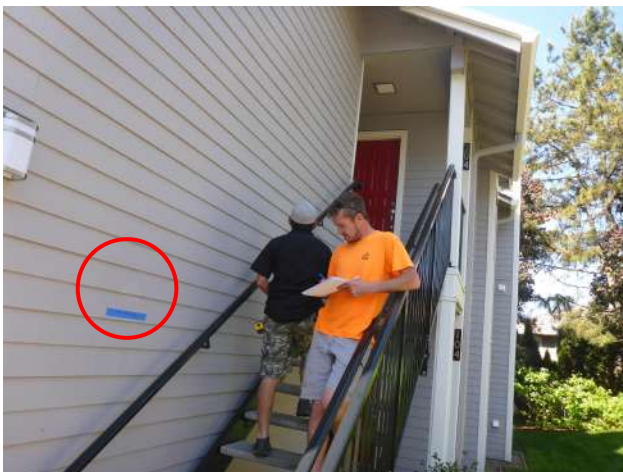
Bldg. B

Unit 104, side elevation – Contractor to touch up paint at lap siding.

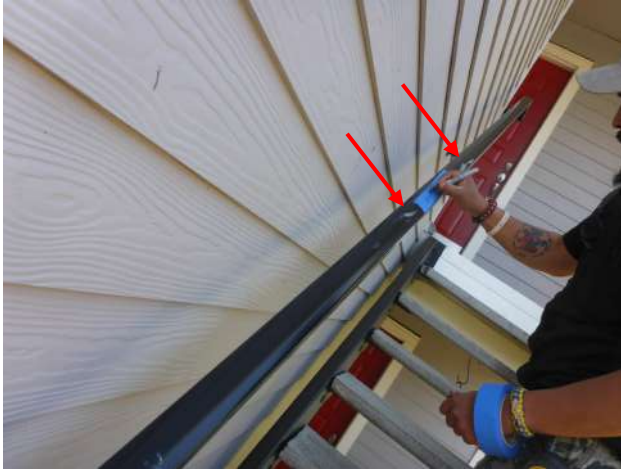
Bldg. B

Unit 104, side elevation – Contractor to clean paint on railings.

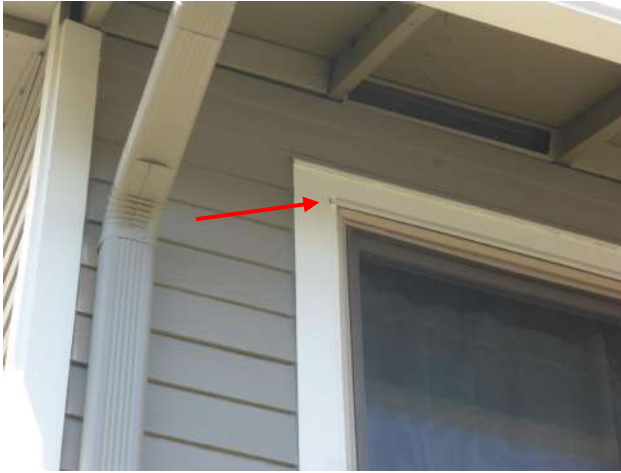
Bldg. C

Unit 202, front elevation – Contractor to repair sealant joint void at window head corner dynamic joint.

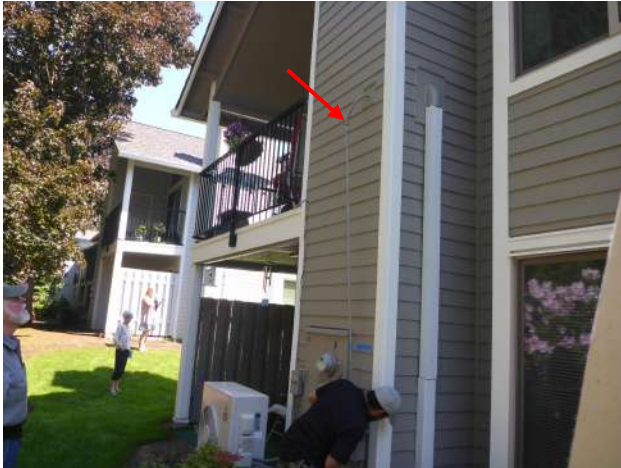
Bldg. C

Unit 104, rear elevation – Contractor to securely and properly attach electrical conduit.

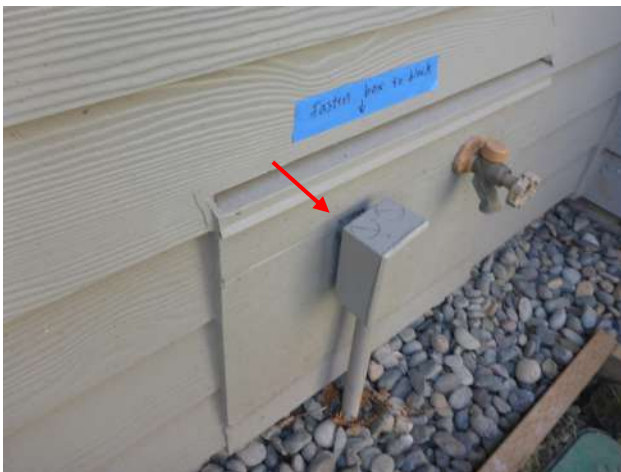
Bldg. C

Unit 104, side elevation – Contractor to securely and properly attach electrical junction box.

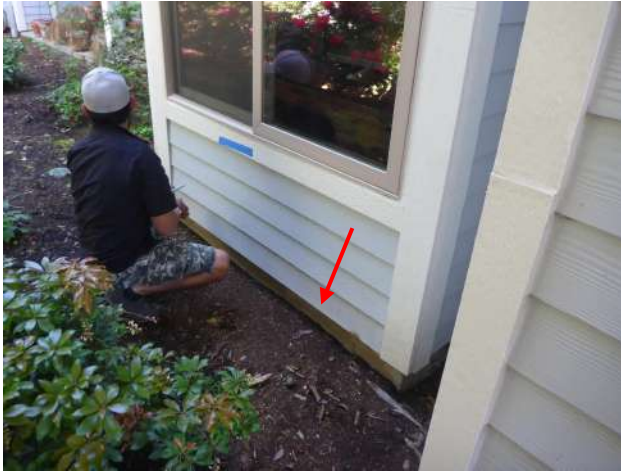
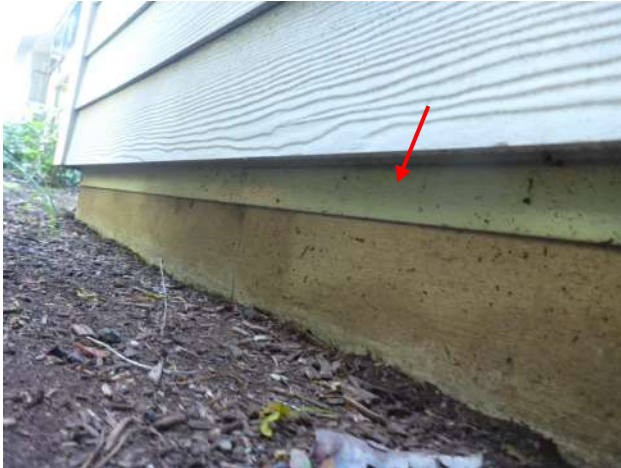
Bldg. D

Unit 101, rear elevation – Contractor to apply paint at omitted areas on base of wall flashing.

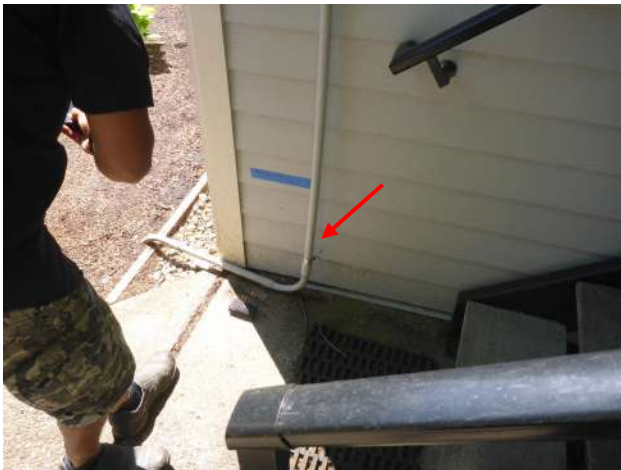
Bldg. D

Unit 106, side elevation – Contractor to securely and properly attach electrical conduit.

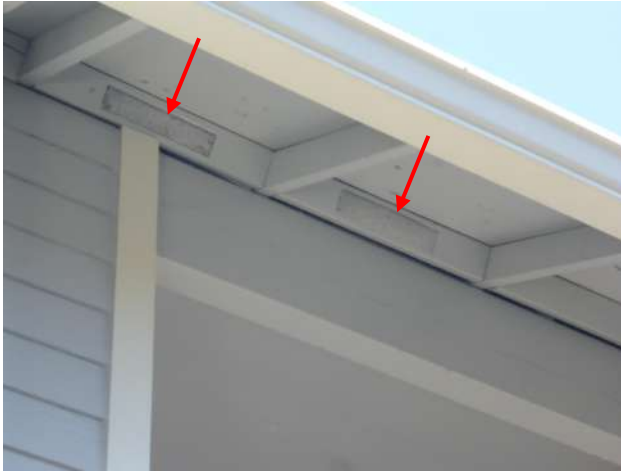
Bldg. D

Unit 202/203, front elevation – Contractor to remove paint from eave vent screens to allow proper flow and movement of air through.

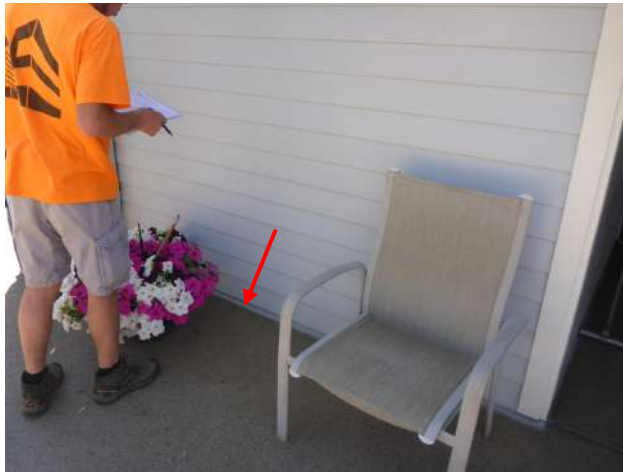
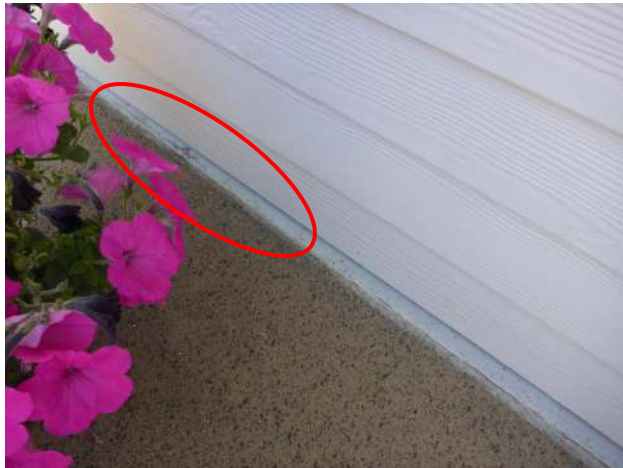
Clubhouse Building

Pool elevation – Contractor to touch up paint at omitted areas on base of wall flashing.

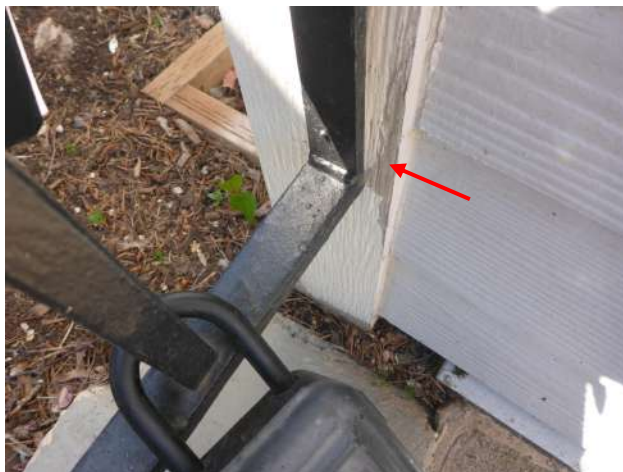
Clubhouse Building

South elevation – Contractor to touch up paint at outside corner trim and pool fence attachment.

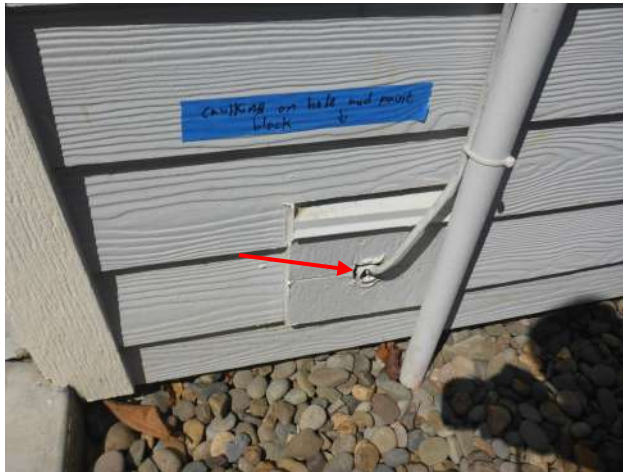
Clubhouse Building

South elevation – Contractor to install missing at pipe penetration. Touch up with paint to match building.

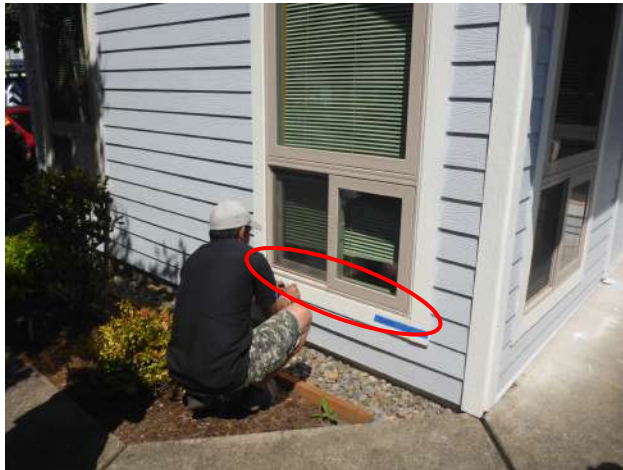
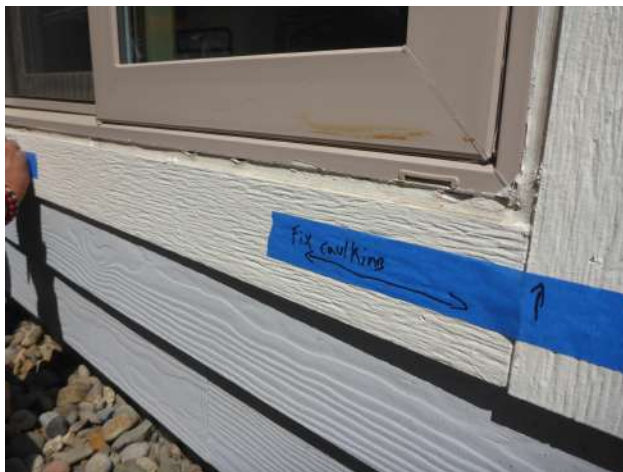
Clubhouse Building

Side elevation – Contractor to repair sealant joint void at window sill dynamic joint.
